# **No Net Loss of Fish Habitat: An Audit of Forest Road Crossings of Fish-Bearing Streams in British Columbia, 1996-1999**

D.J. Harper and J.T. Quigley

**Canadian Technical Report of  
Fisheries and Aquatic Sciences 2319**

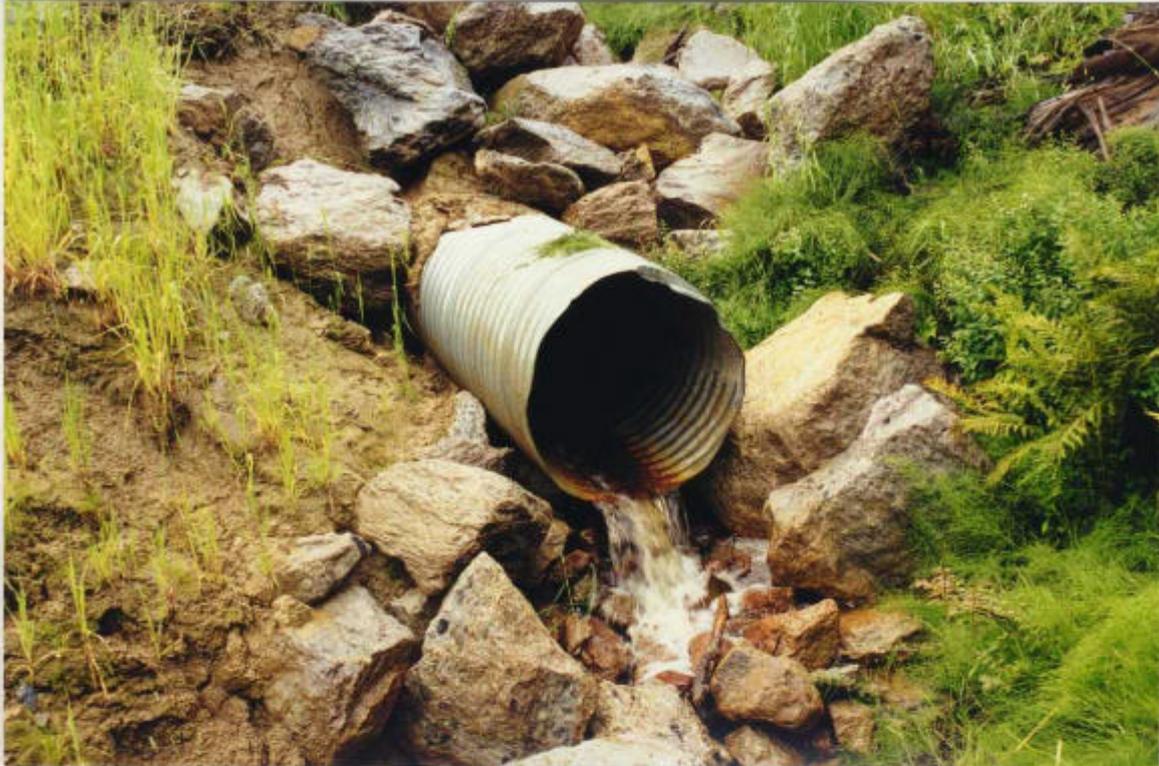
The total stream habitat loss (habitat loss due to encroachment plus benthic loss) totalled 562 m<sup>2</sup> in the PGFD (n=23) compared to 110.3 m<sup>2</sup> in the PMFD (n=23). In the PGFD, 70% of the crossings resulted in a habitat loss due to encroachment and 52% of the crossings caused a benthic loss. Only 26% of the crossings in the PMFD resulted in a habitat loss due to encroachment, and none of the crossings resulted in a benthic loss. The loss of stream habitat in the PGFD was greater than that of the PMFD due to the fact that 100% of the CMPs installed in the PGFD encroached on their respective channels and none of them were embedded (see photographs 1 & 2 in Appendix 2).

**Photograph 1.** Stream crossing PG2-2. The 0.750 m wide post-FPC CMP was only 22% of the width of the bankful width of the stream channel (3.45 m). This resulted in a velocity barrier and an outlet barrier.

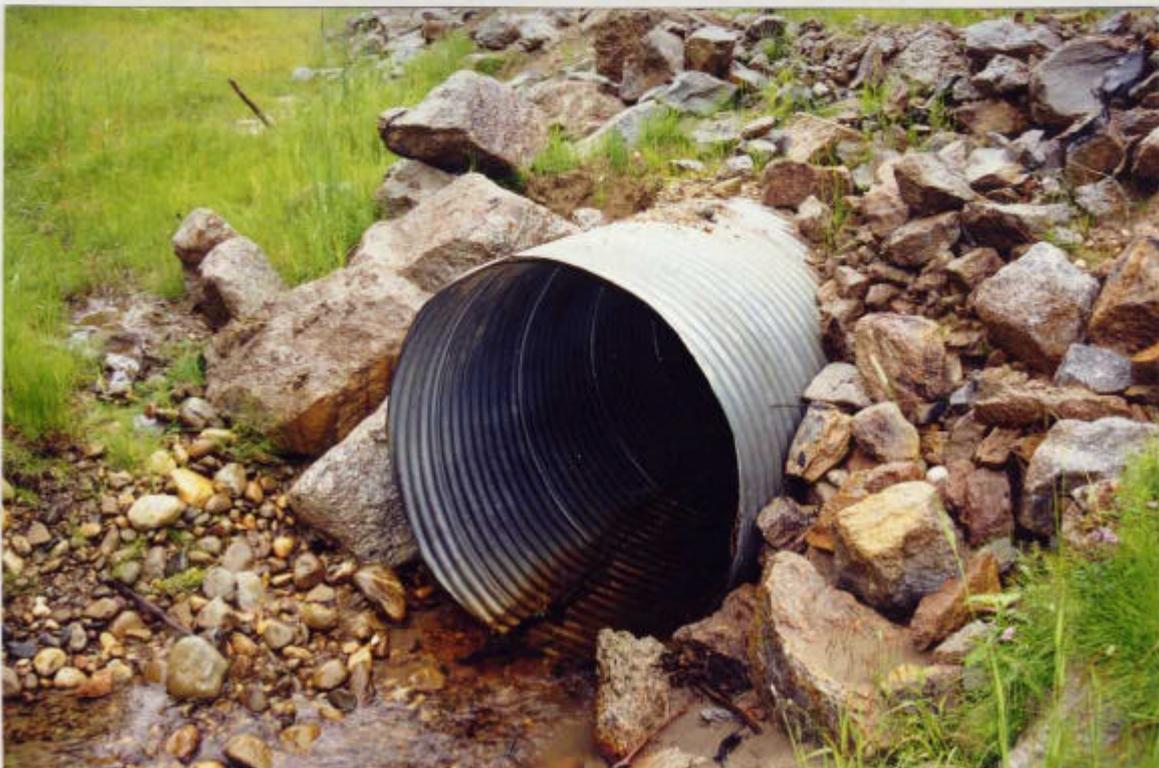
**Photograph 2.** Inlet of culvert at stream crossing PG2-1. The crossing width was only 29% of the channel width. Note that the ditchline flows directly into the creek.

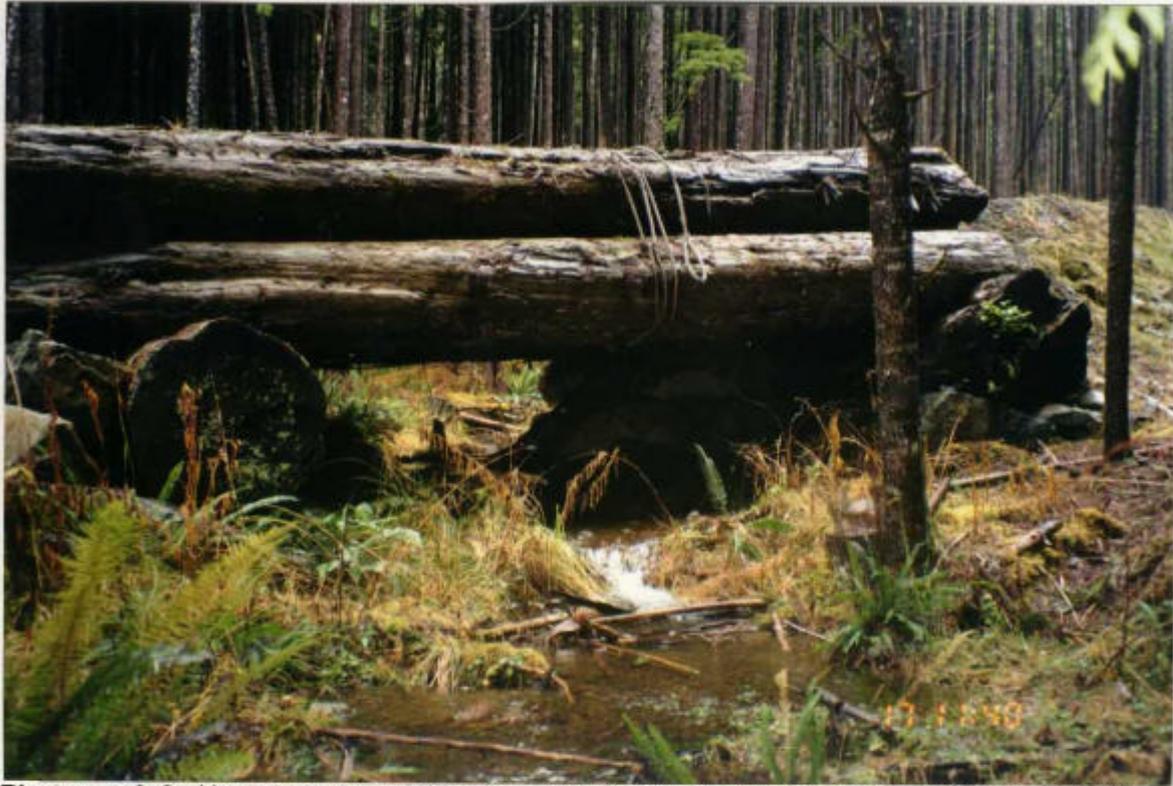
From Table 5 and Figure 7, it is apparent that LCs and bridges generally do not result in a stream encroachment (see photographs 3 & 4 in Appendix 2). Four of the bridge crossings reviewed did result in a habitat loss due to encroachment because their bridge decks were too short to extend across the channel properly, and as a result, required more riprap to protect bridge abutments (see photographs 5, 6, & 7 in Appendix 2). In comparing pre-FPC and post-FPC CMPs, it is clear that undersized culverts continue to be installed on fish-bearing streams in the PGFD. Moreover, 58% of CMPs reviewed by this study, all of which were non-embedded, were installed at gradients greater than the 0.5% SCG-recommended gradient for non-embedded culverts.

**Photograph 3.** Upstream view of crossing PM2-8 showing benefits of LC technique. Note the crossing width was 1.74 times greater than the channel width (2.19 m).

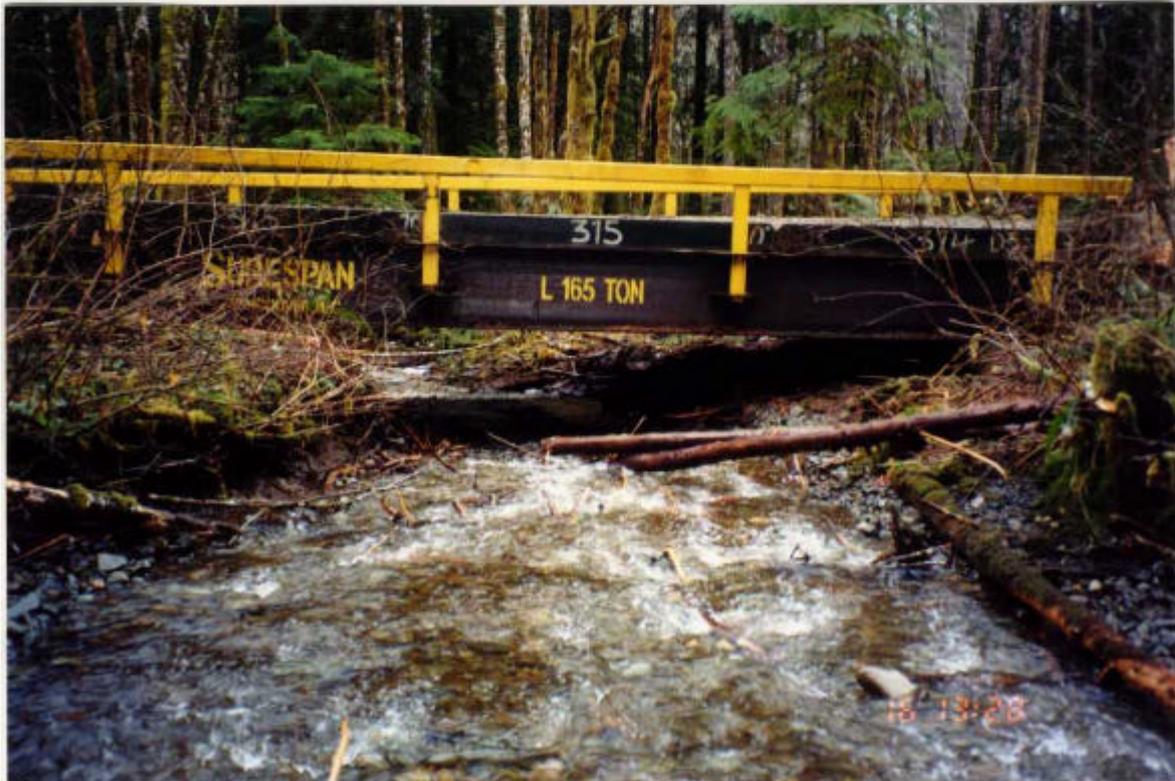
**Photograph 4.** Stream crossing PM2-3. This crossing width was 1.35 times greater than the channel width. Streambank integrity was maintained.

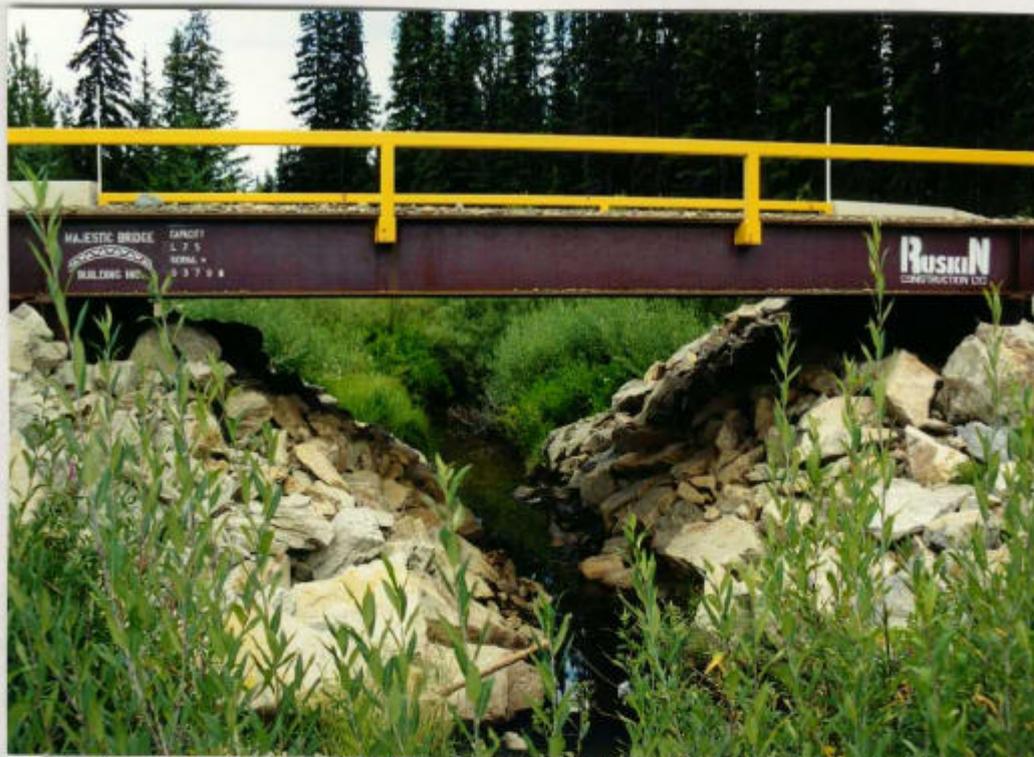
**Photograph 5.** Stream crossing PG1-3. Note the excessive rip-rap placed on the streambanks. The crossing width was only 51% of the stream channel.

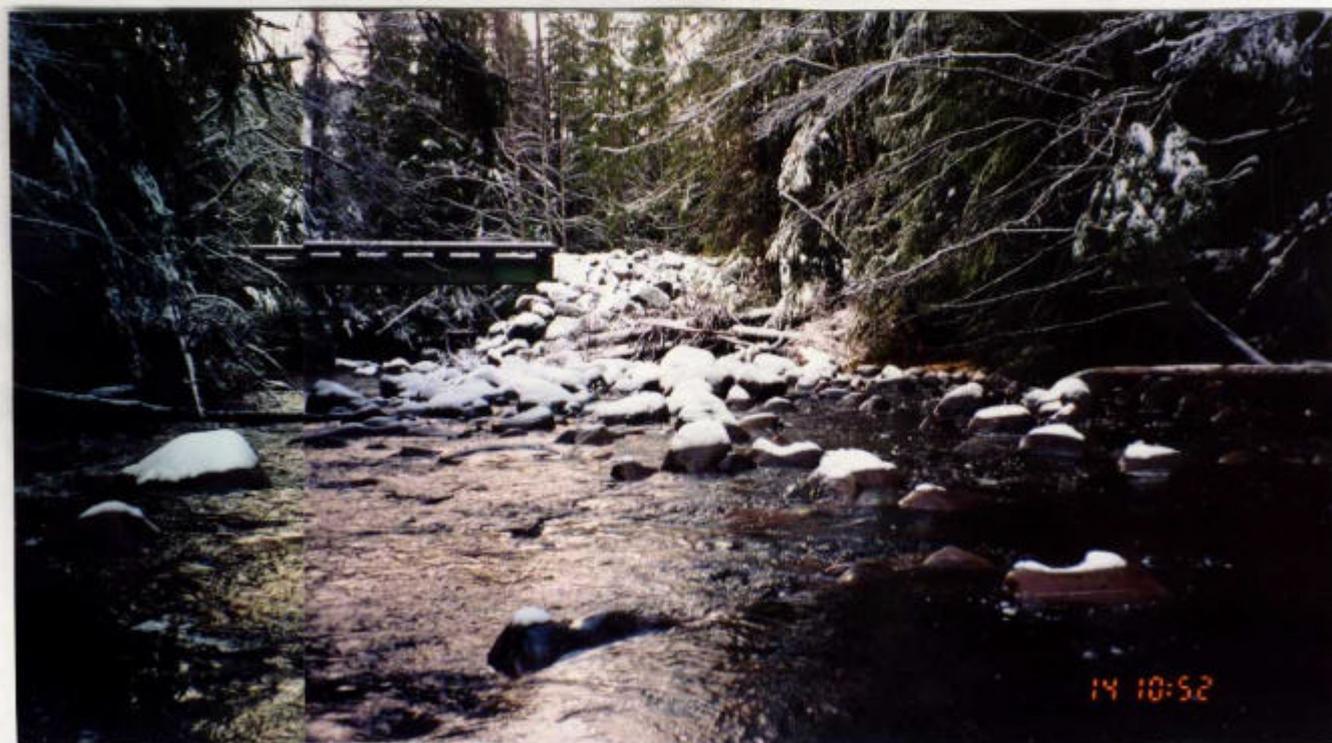
**Photograph 6.** Downstream view of crossing PM1-4. This crossing width was 60% of the channel width. Note the encroachment due to the right approach.

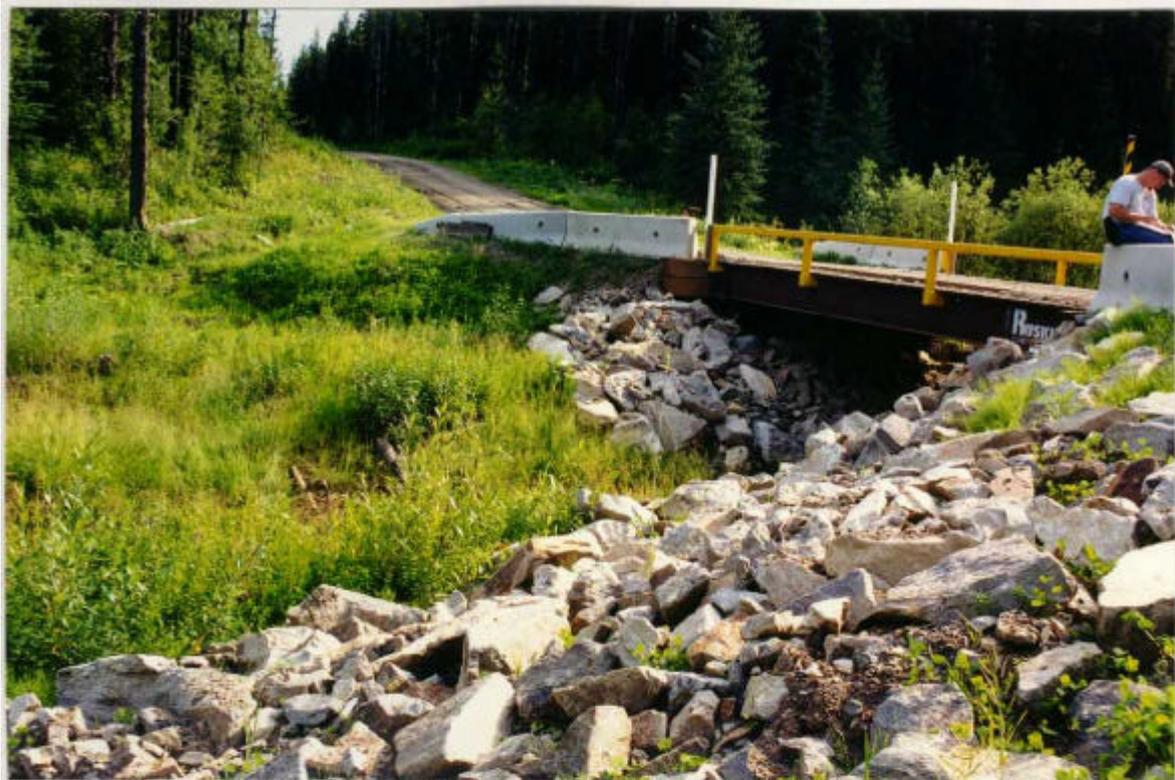
**Photograph 7.** Stream Crossing PG1-5. Note the excessive rip-rap placement in foreground and corresponding permanent loss of riparian vegetation.

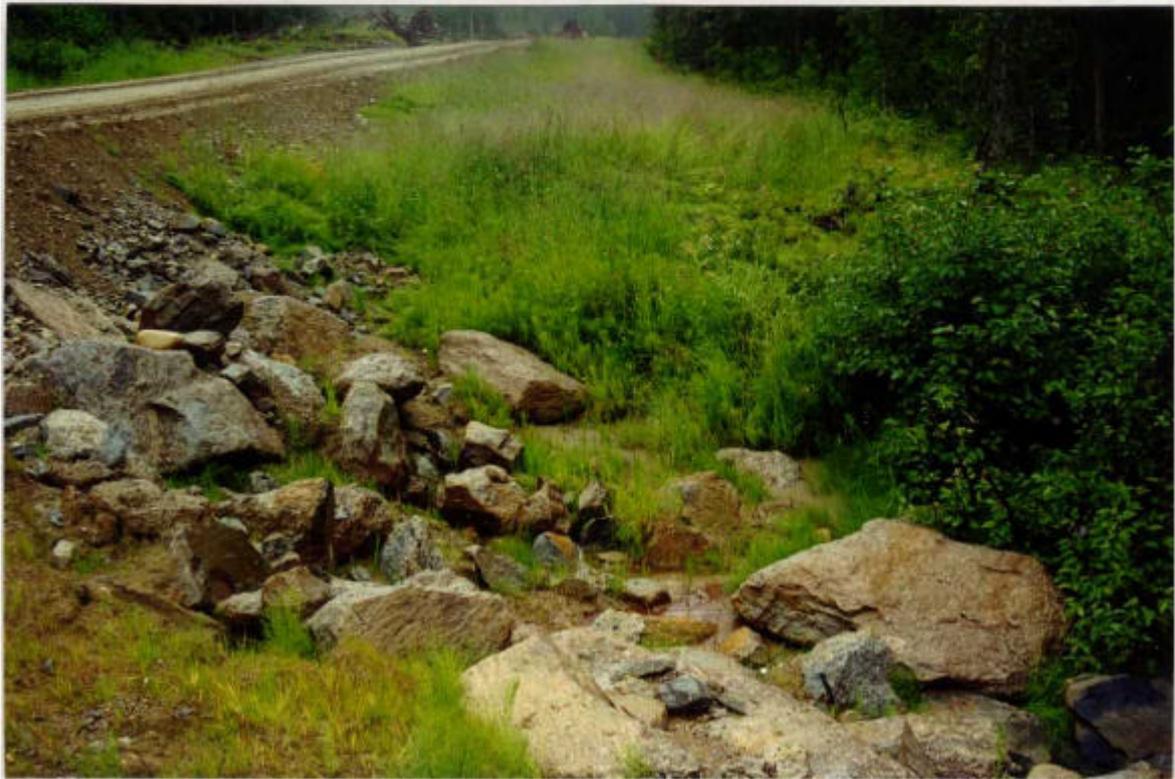
**Photograph 8.** Downstream banks at stream crossing PG2-1. Note the width of the right-of-way and the excessive rip-rap adjacent to the creek.

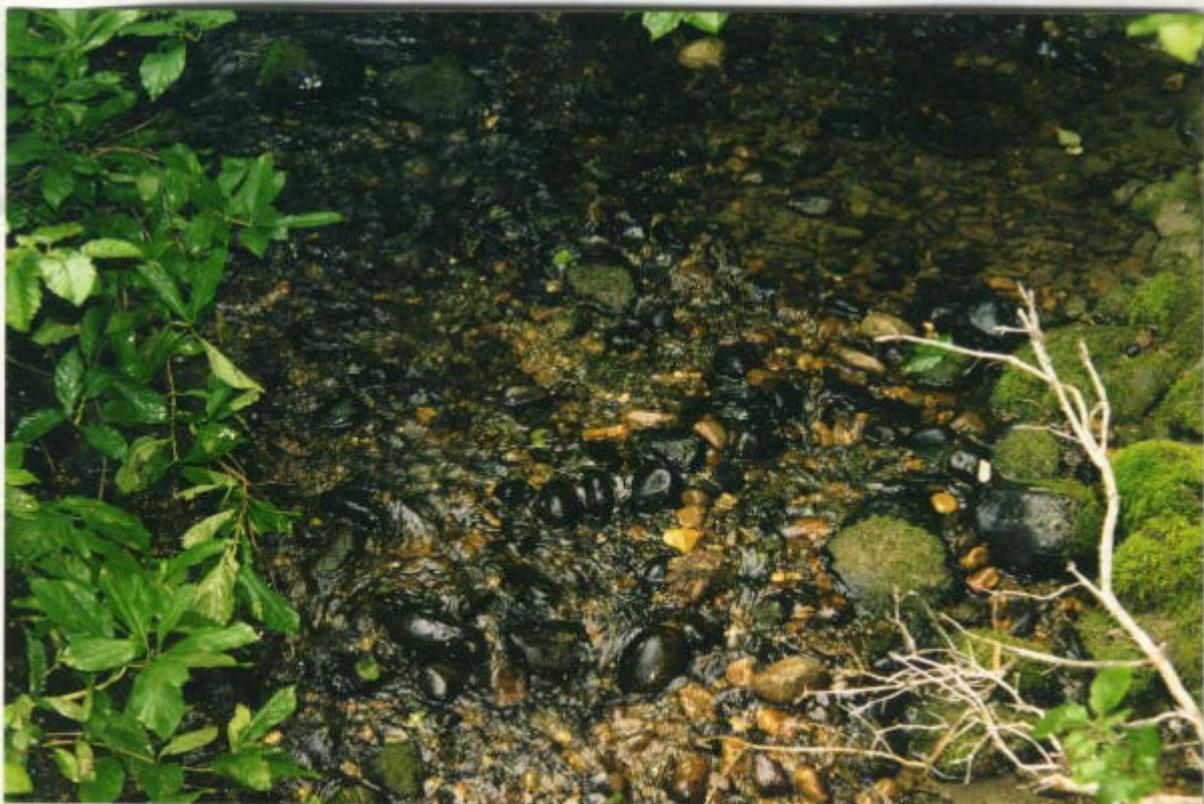
**Photograph 9.** Gravel/cobble streambed substrate upstream of culvert PG2-1.

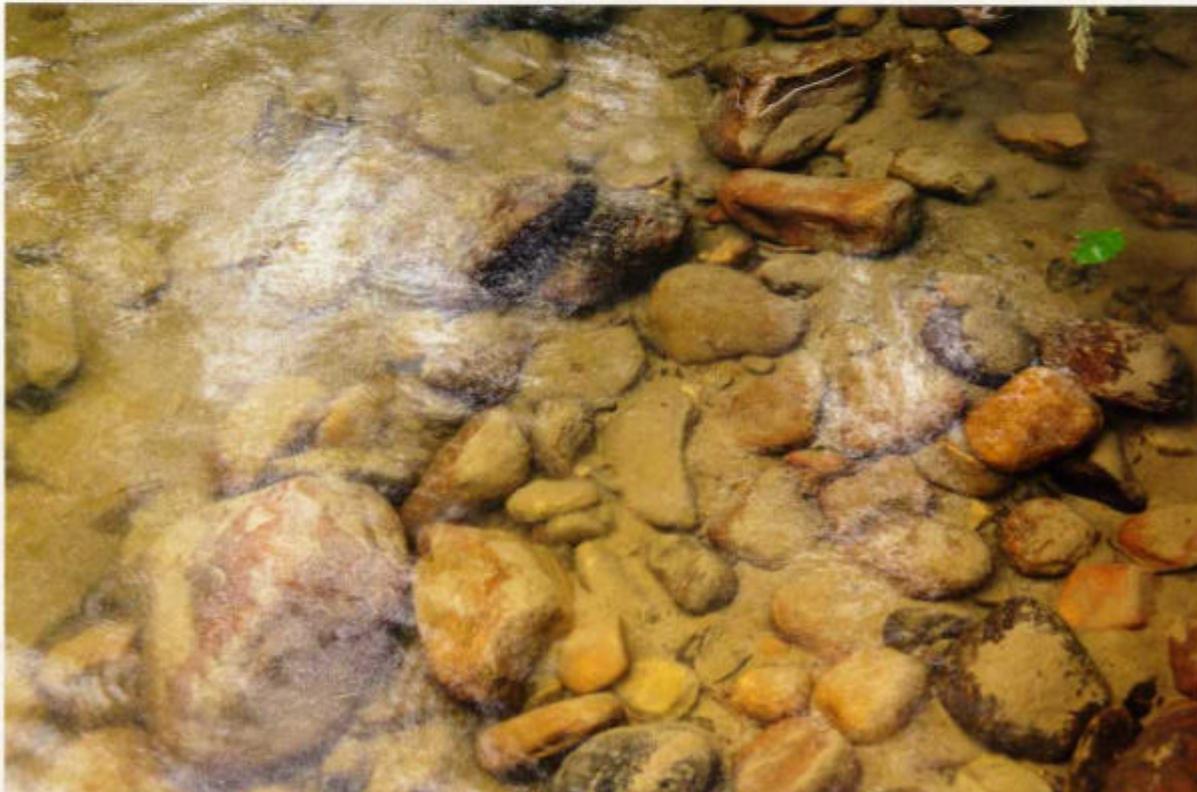
**Photograph 10.** Sediment inundated gravel/cobble substrate downstream from stream crossing PG2-1.

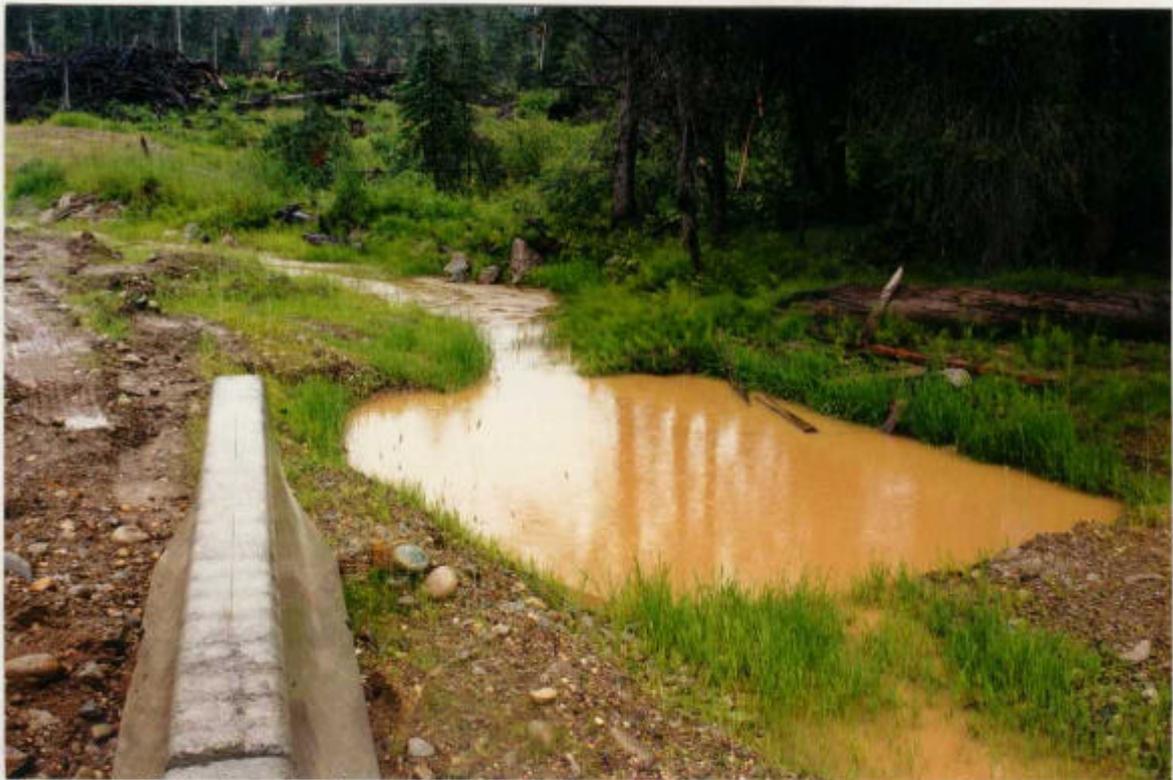
- Overflowing sediment ponds (see photograph 11 in Appendix 2);
- Inappropriate application of silt fences (as a fish barrier, perpendicular to flow in the stream) (see photographs 12);
- Un-maintained ditches without gravel lining or check-dams ponds (see photographs 1, 8, & 11 in Appendix 2);
- Sediment fallout from bridge decks and unstable road fill failing into stream;
- Exposed and disturbed streambanks without re-vegetation, mulching, re-sloping, silt fencing or other bioengineering techniques.

**Photograph 11.** Over-flowing settling pond and sediment clogged ditches that flow directly into the stream at crossing PG2-3.

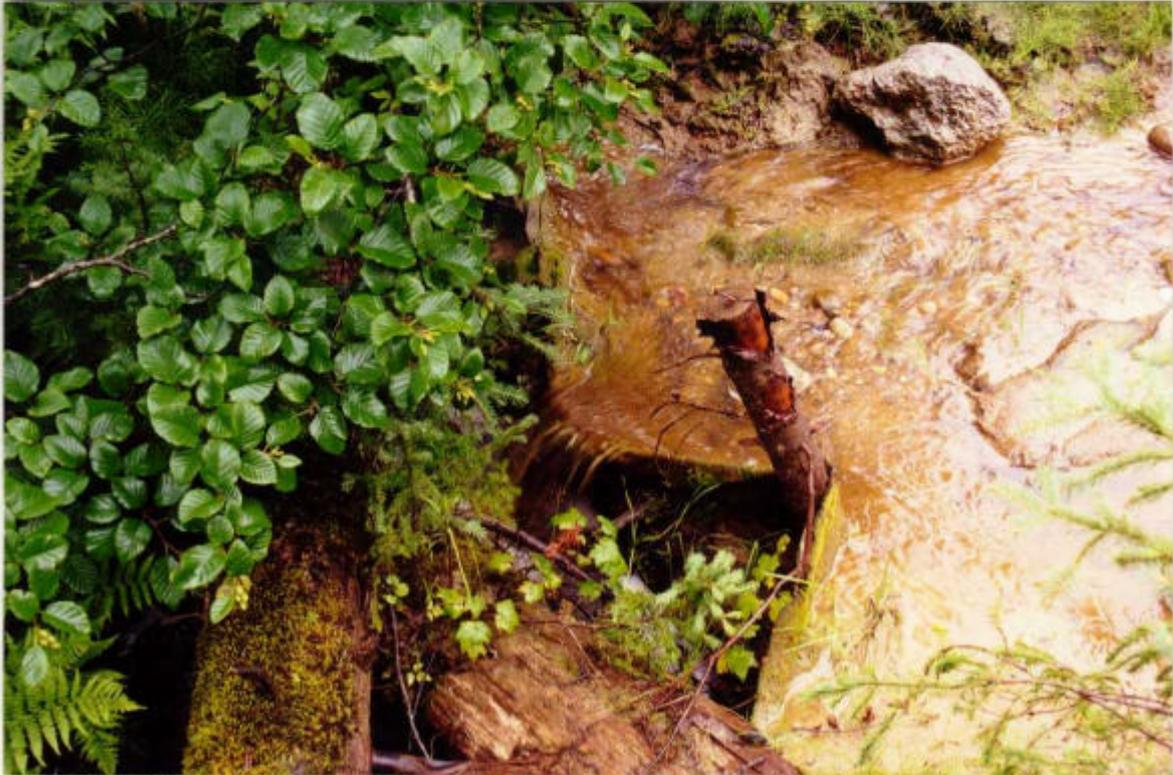
**Photograph 12.** Silt fence improperly installed in the stream channel downstream of crossing PG2-2. The silt fence resulted in a 0.28 m vertical obstruction.
